**CALSPAN ON-SITE AIR BAG DEPLOYMENT INVESTIGATION**

**CALSPAN CASE NO. 91-3**

**VEHICLE - 1990 GEO STORM GSi  
LOCATION [REDACTED], LOUISIANA  
ACCIDENT DATE - [REDACTED] 1990**

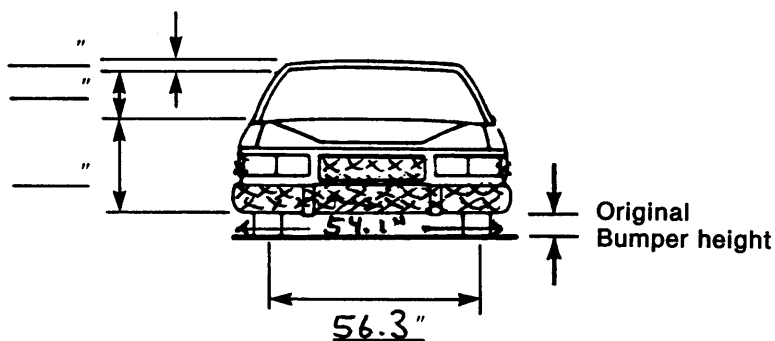
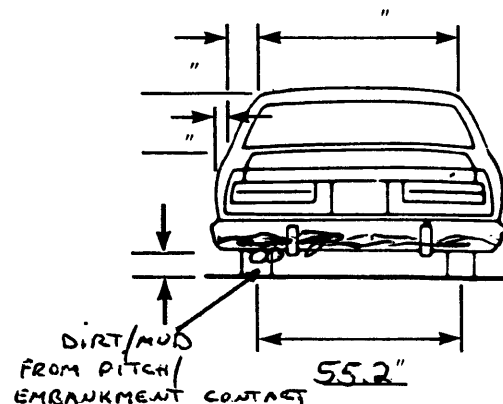
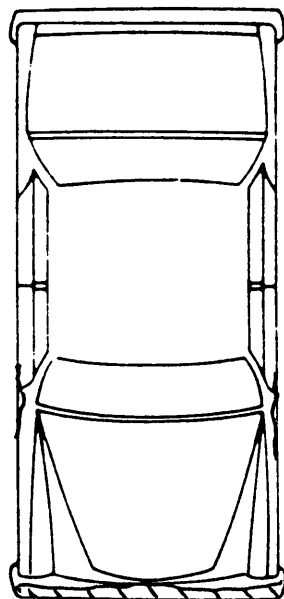
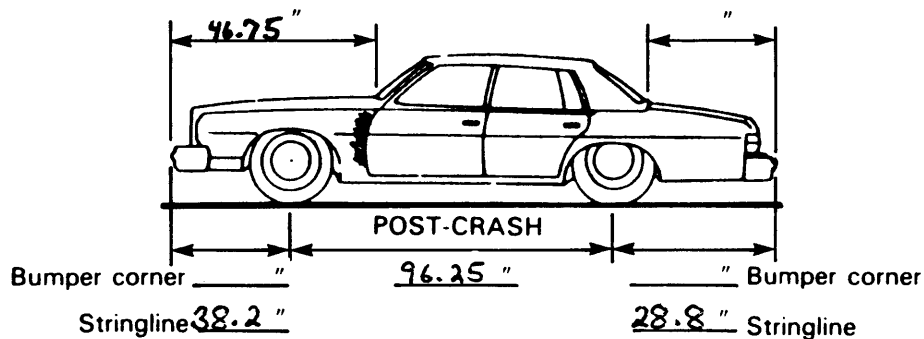
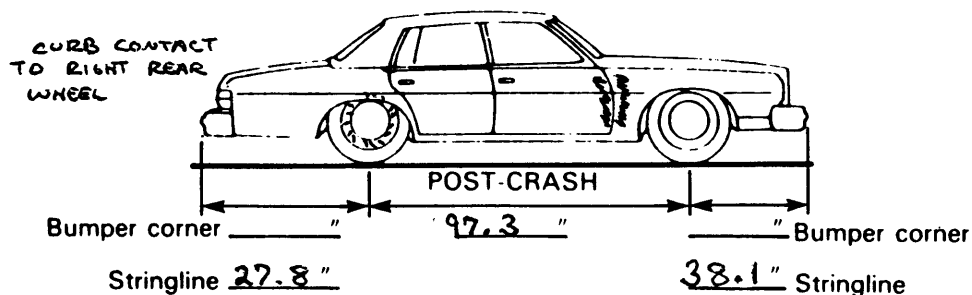
## VEHICLE DAMAGE SKETCH

Specific Impact No.	Location of Direct Damage	Location of Field L	Location of Maximum Crush
1	RR ALUMINUM WHEEL		
2	FRONT BUMPER, DISTRIBUTED	FULL FRONTAL WIDTH	AT LF BUMPER CORNER

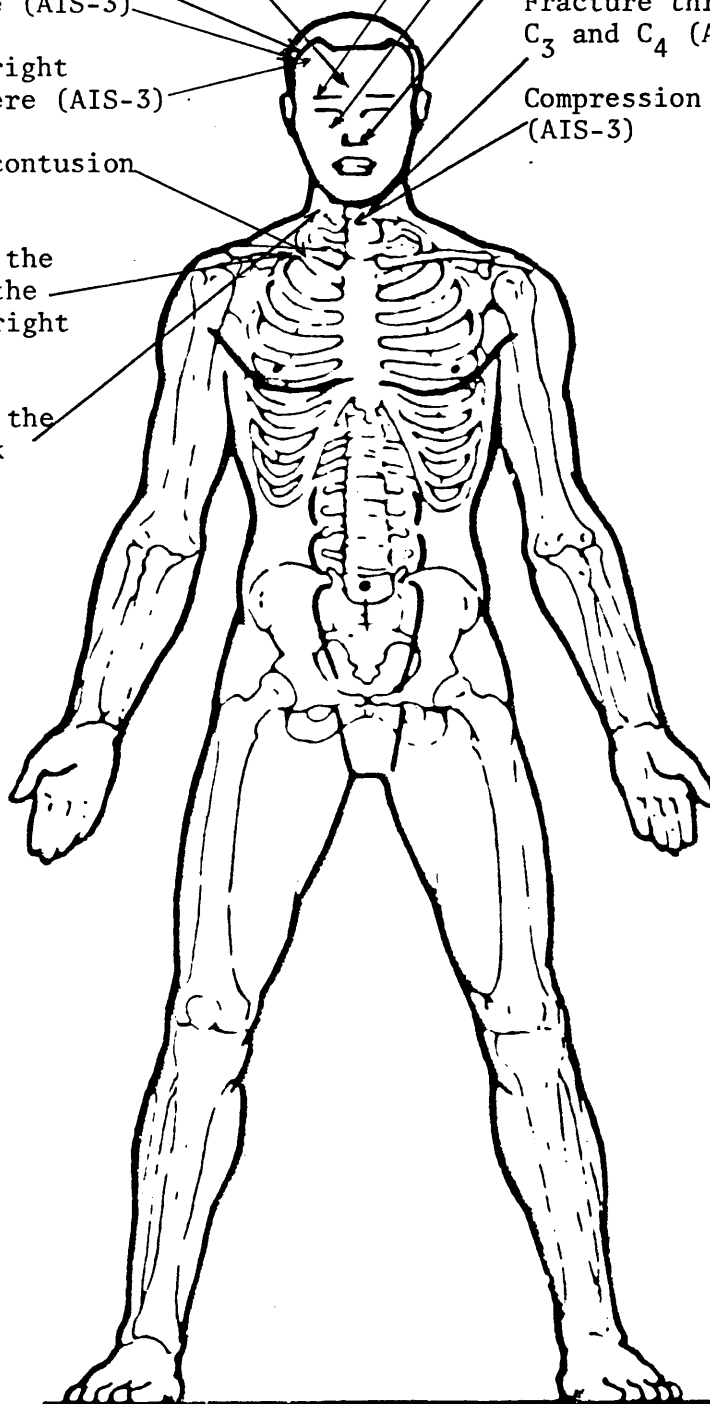
- Fracture of the right orbit (AIS-2)
- Large hinge fracture through the base of the skull (AIS-4)
- Cerebral edema (AIS-4)
- Subdural hemorrhage (AIS-3)
- Contusions of the right cerebellar hemisphere (AIS-3)
- Upper right chest contusion (AIS-1)
- Large contusion of the lateral aspect of the upper lobe of the right lung (AIS-3)
- Large contusion of the right anterior neck (AIS-1)
- Fracture of the right maxillary sinus (AIS-2)
- Fractured nasal bones (AIS-1)
- Fracture through the disc at C<sub>3</sub> and C<sub>4</sub> (AIS-2)
- Compression of the spinal cord (AIS-3)
